# Manhole Inspection Summary

Manhole # S05YY1009MH

**Location** Address: **5915 BLAND AVE**

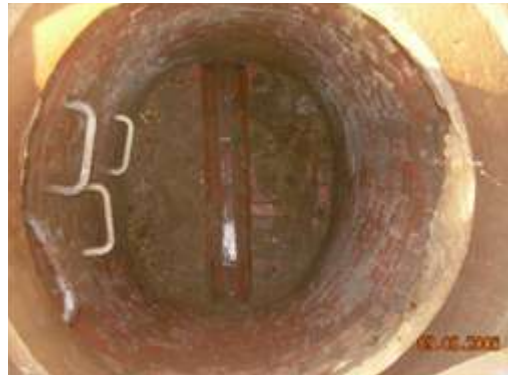
Top View

Corroded steps. Evidence of surcharge - Bench debris.

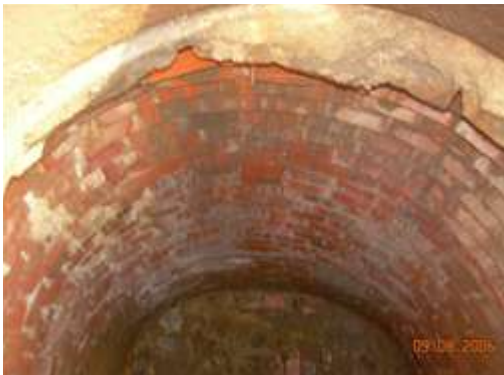
Defect

**Frame** Offset: **2** (in.) Condition: ☐ Sound ☐ Cracked ☒ **Leaks**

Condition: ☐ Sound ☐ Cracked ☐ Root Intrusion ☒ **Loose Brick** ☐ Deteriorated

Infiltration: ☐ None ☒ **Joint** ☐ Cracks ☒ **Mortar** ☐ Roots ☐ Wall

Frame leaks. Adjustment loose brick.  
Adjustment, Corbe and Barrell infiltration.

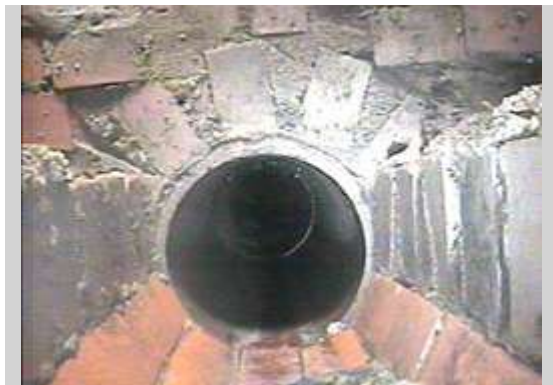
Pipe Out @ 12 O'Clock

Invert Depth: **8.50** (ft.) Flow Characteristics: **Slow**

Infiltration: **None** Pipe Seal Cond: **Unknown**

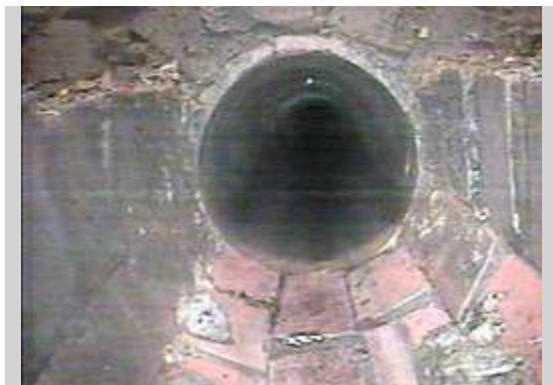
Pipe In @ 6 O'Clock

Invert Depth: **8.24** (ft.) Flow Characteristics: **Slow**

Infiltration: **None** Pipe Seal Cond: **Unknown**
